Technical Report HL-90-2
September 1997

Red River Waterway, Lock and Dam No. 4

Report 2 Navigation Alignment Conditions

Hydraulic Model Investigation

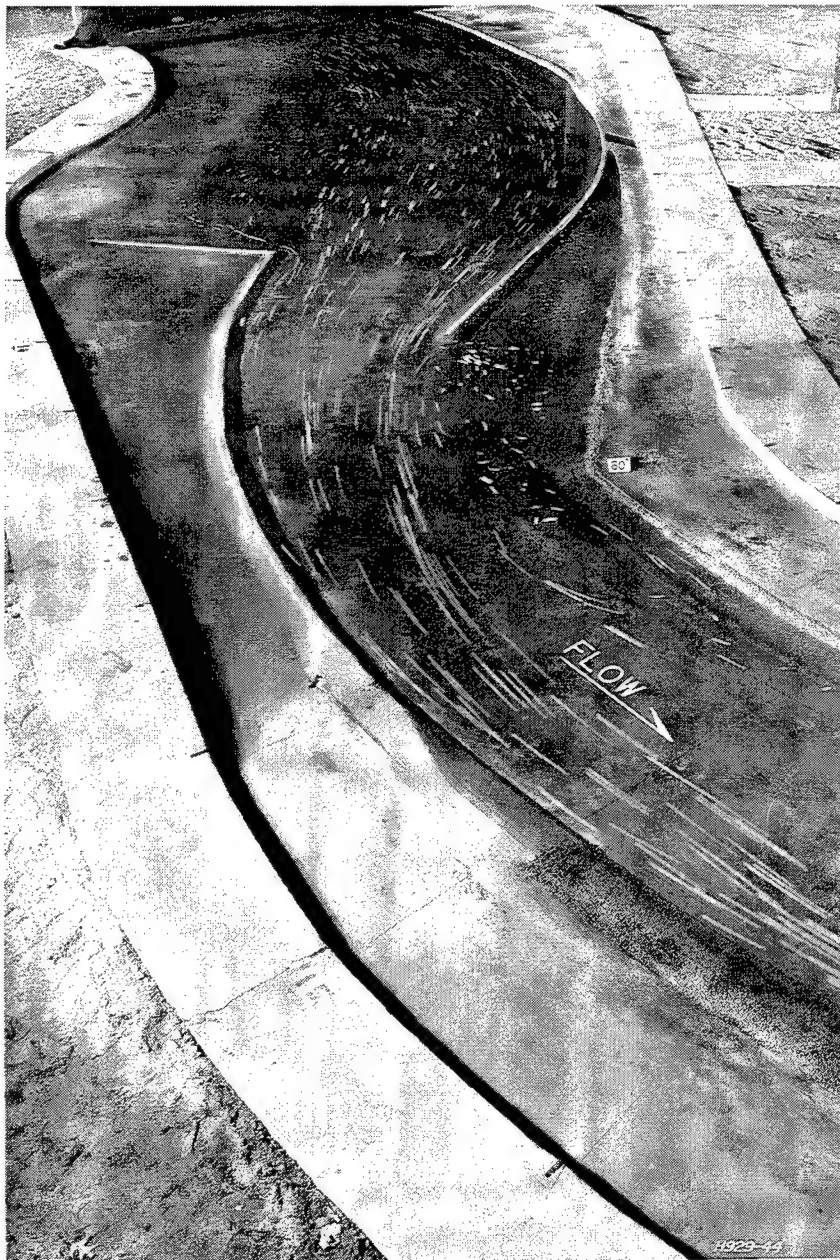
Photo 1. Plan B, looking upstream, discharge 60,000 cfs. Confetti showing surface current patterns entering and through Piermont cutoff

Current direction and velocity data, shown in Plates 1-5, indicate a concentration of flow through the constriction formed by the convergence of the stone-fill dikes at the upstream entrance to Piermont cutoff (Photo 1). The

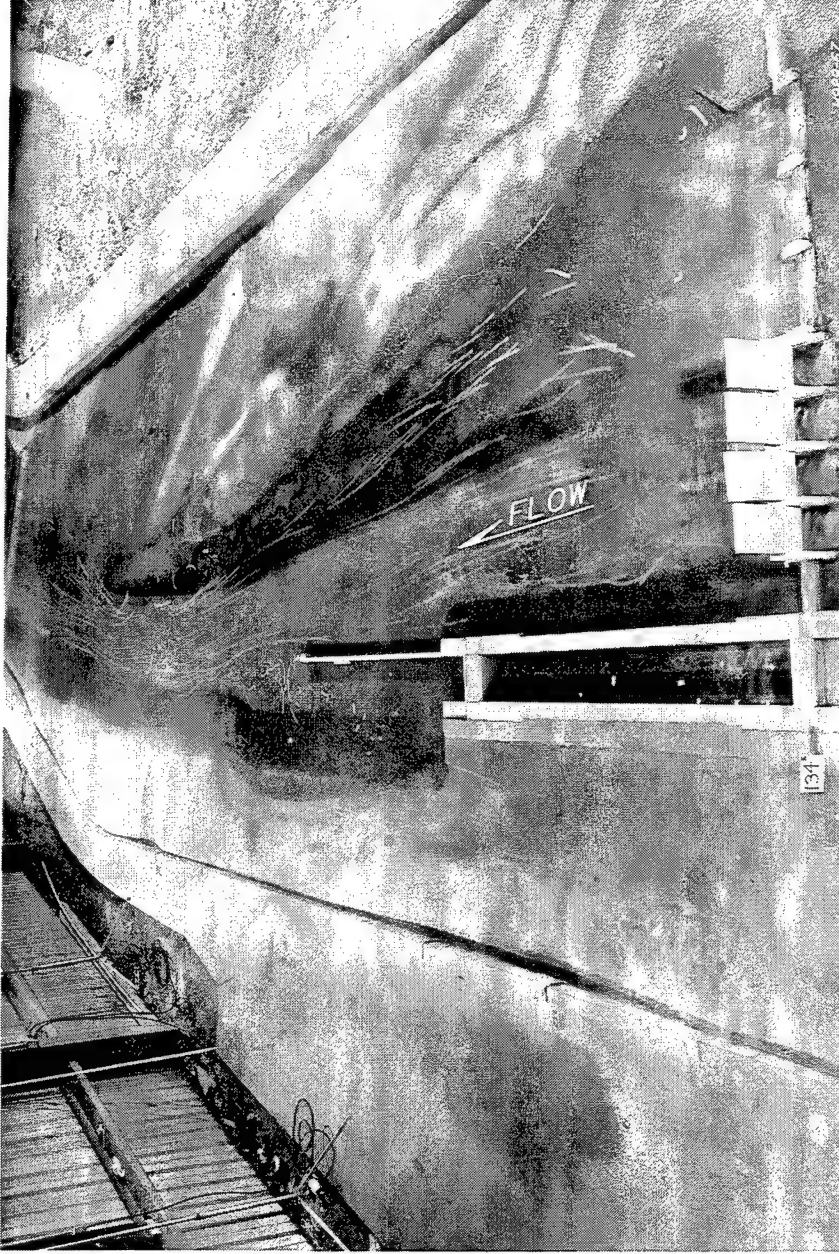
Photo 3. Plan B, looking downstream, discharge 134,000 cfs. Confetti showing surface current patterns in the lower lock approach

Currents downstream of the dam were directed toward the left descending bank, across the lower lock approach, where the flow then crossed the main channel toward the right bank in the direction of the old river channel (Photo 3). The maximum current velocity across the lower lock approach downstream of the lower guard wall ranged from 5.5 to 10.1 fps with riverflows of 20,000 and 80,000 cfs, respectively. A counterclockwise eddy was observed in the lower lock approach with upstream velocities ranging from 1.0 to 5.2 fps with riverflows of 20,000 and 80,000 cfs, respectively. The maximum current velocities recorded in the lower pool generally occurred in the vicinity of the lower guard wall with maximum velocities ranging from 6.1 to 14.9 fps with riverflows of 20,000 and 134,000 cfs, respectively. The velocity of the currents across the lower lock approach and the size of the eddy decreased in magnitude somewhat with riverflows above 80,000 cfs due to the increase in flow area.

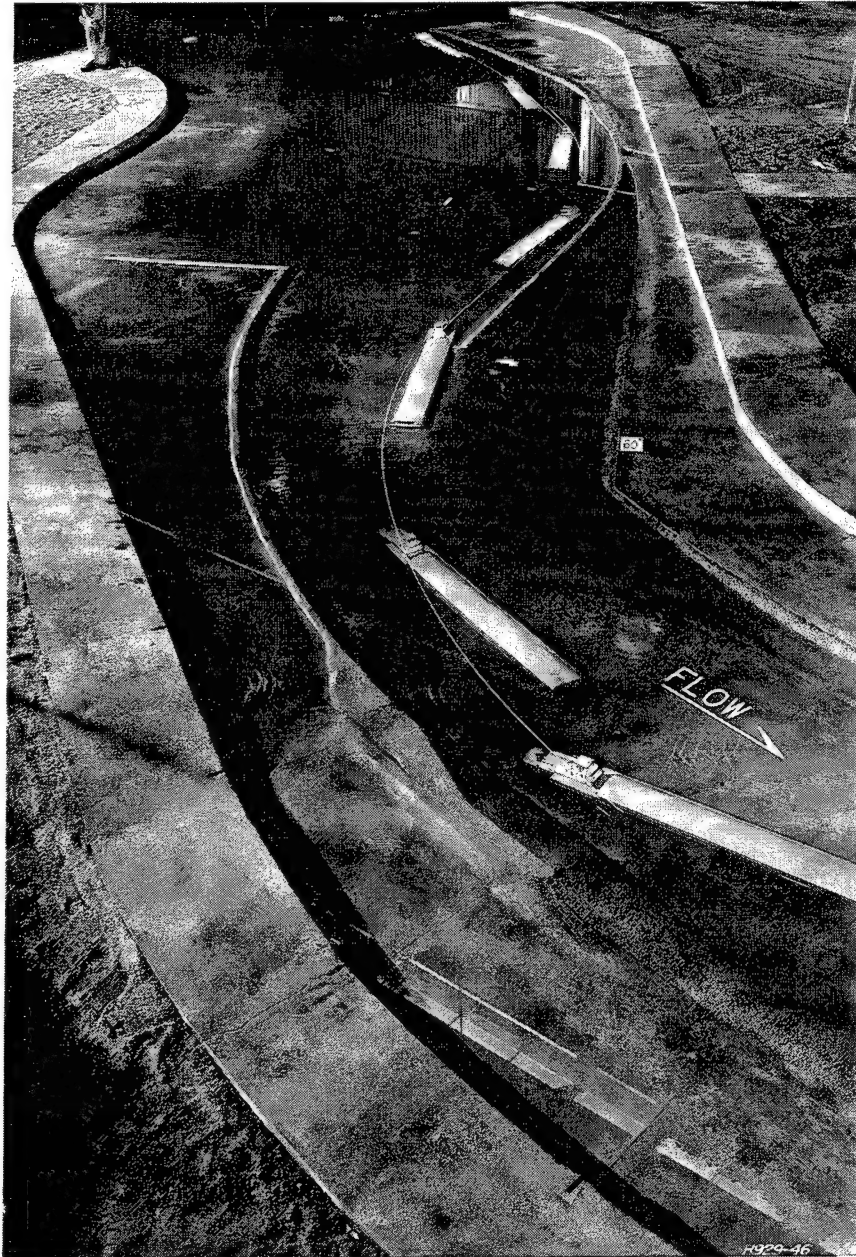
Photo 4. Plan B, looking upstream, discharge 60,000 cfs. Path of down-bound tow entering Piermont cutoff. Note tendency for tow to be confined against right descending bank

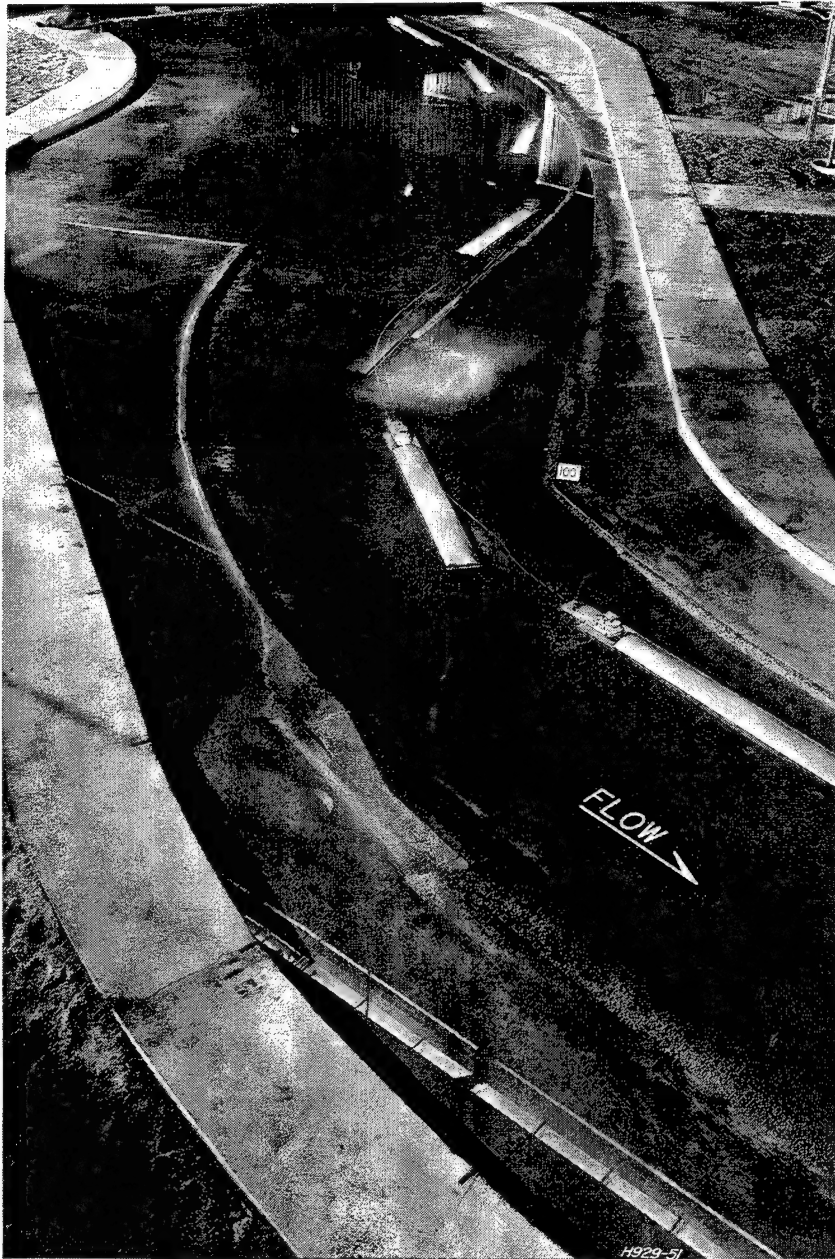
Photo 5. Plan B, looking upstream, discharge 100,000 cfs. Path of down-bound tow flanking into Piermont cutoff

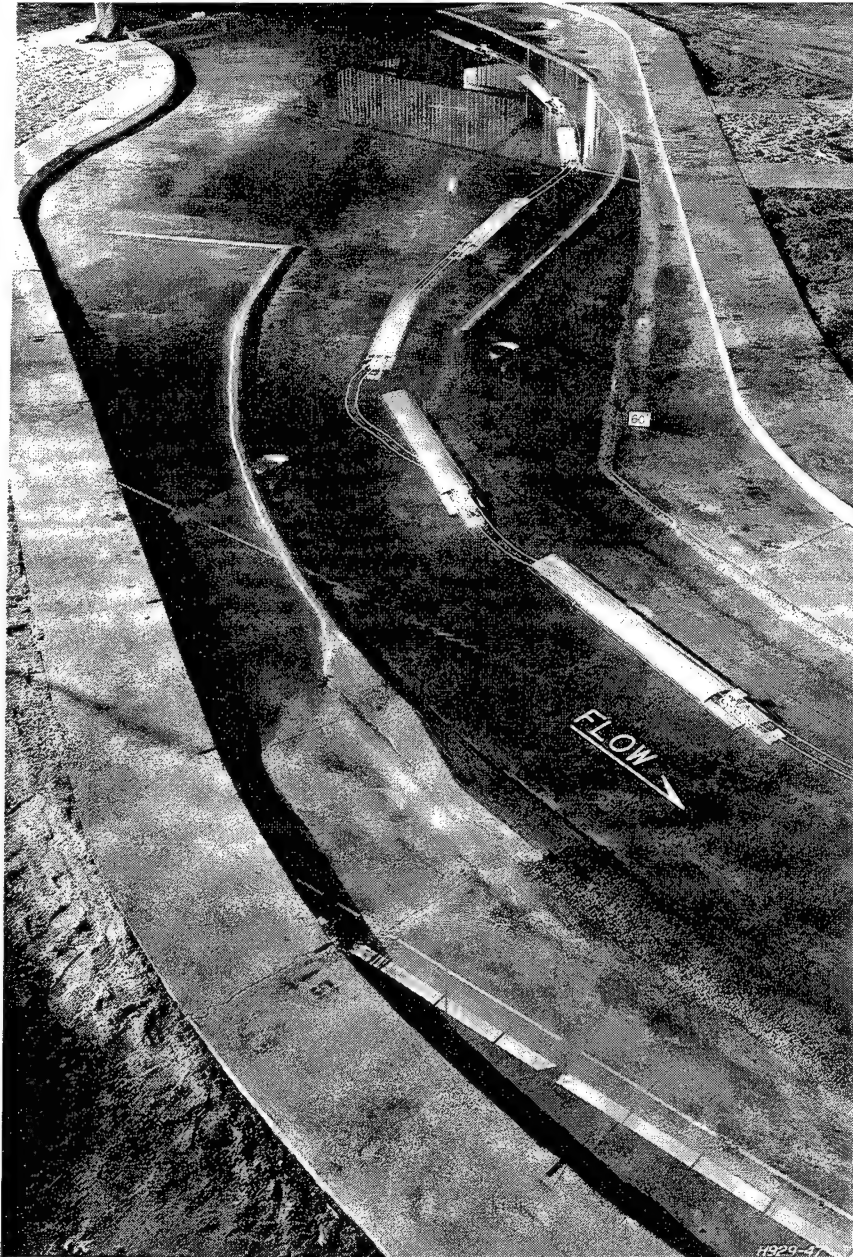
Photo 6. Plan B, looking upstream, discharge 60,000 cfs. Path of upbound tow leaving Piermont cutoff. Note maneuvering near end of Bull Revetment

No major difficulties were indicated for upbound tows navigating through the bendway, but it should be noted that considerable maneuvering was required to move through the constriction at the upstream entrance to Piermont cutoff because of the alignment of currents through this reach (Photo 6).

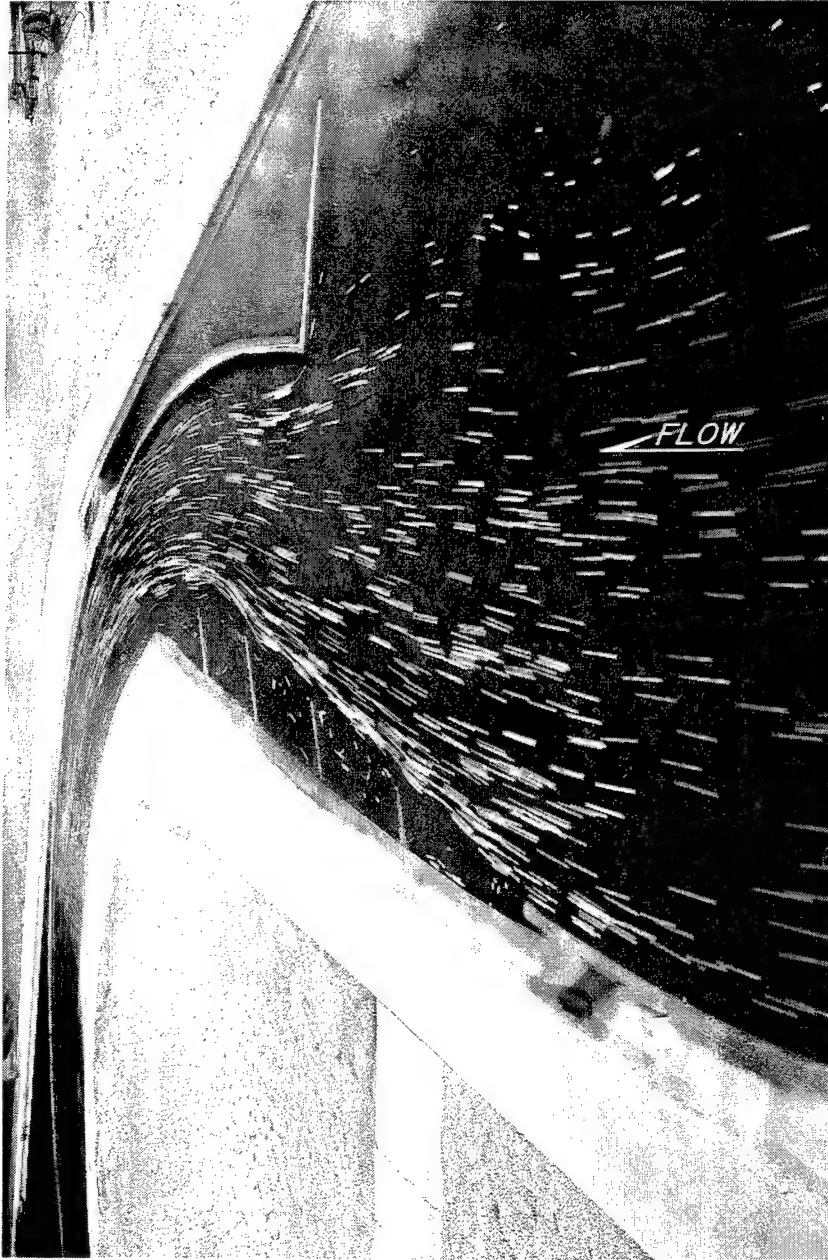
Photo 11. Plan C, looking downstream, discharge 80,000 cfs. Confetti showing surface current patterns entering and through Piermont cutoff

to 9.1 fps with riverflows of 20,000 and 134,000 cfs, respectively. In this reach, a reduction in the maximum velocity of the current of about 2.0 fps was observed when compared to Plan B. There was very little difference in current alignment and velocities through the cutoff. The flow appears to be more uniformly distributed at the upstream entrance to the cutoff; however, the flow was still concentrated toward and along the right descending bank of the bendway (Photo 11).

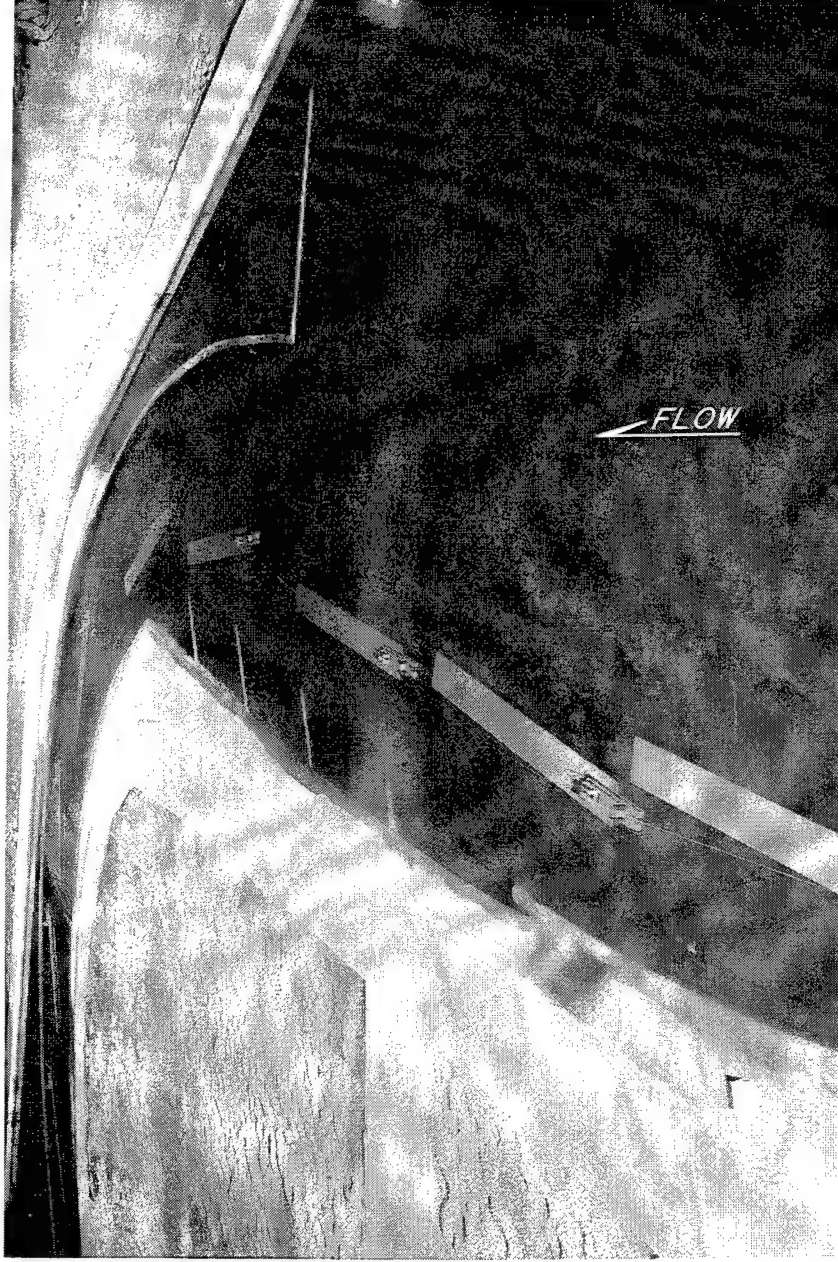
Photo 12. Plan C, looking downstream, discharge 60,000 cfs. Path of downbound tow driving past four spur dikes and into Piermont cutoff

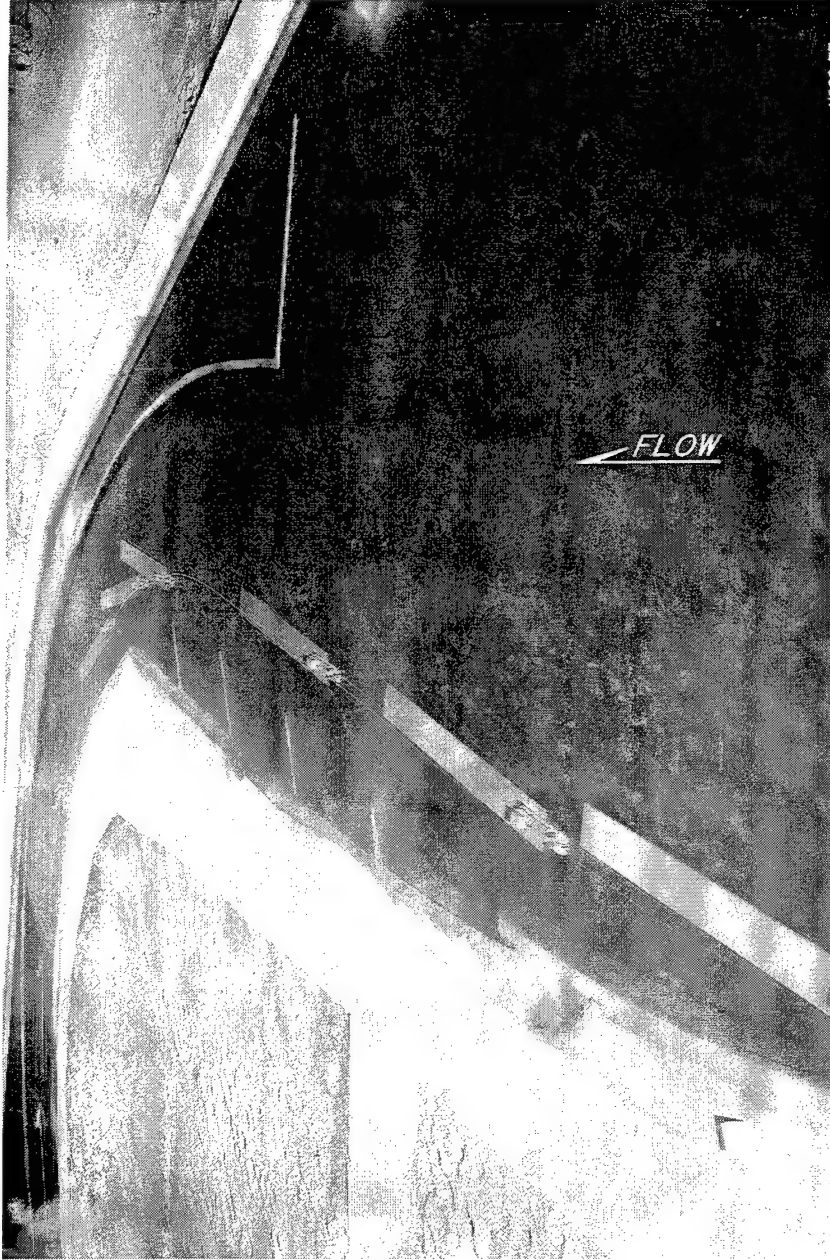
Photo 13. Plan C, looking downstream, discharge 80,000 cfs. Path of downbound tow flanking past four spur dikes and into Piermont cutoff. Note that tow is positioned to inside of bend

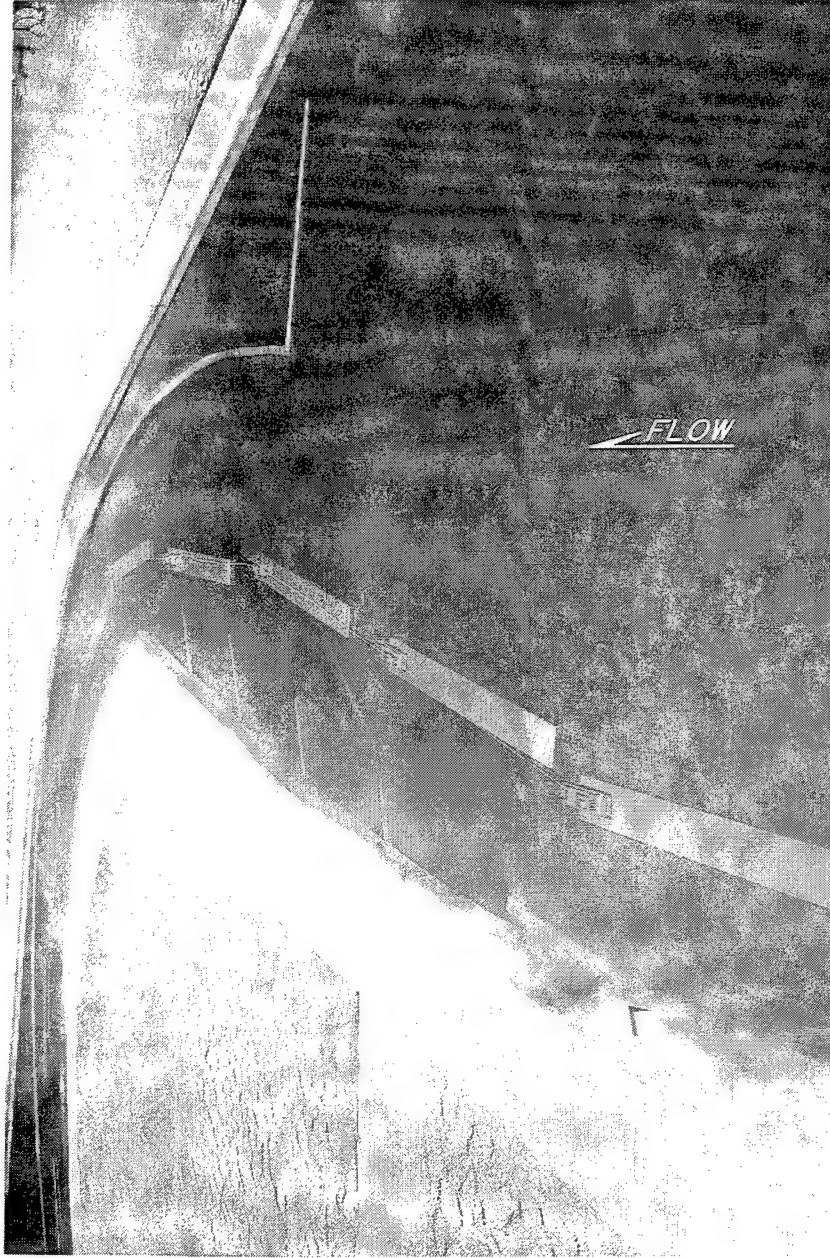
Photo 14. Plan C, looking downstream, discharge 80,000 cfs. Path of upbound tow leaving Piermont cutoff

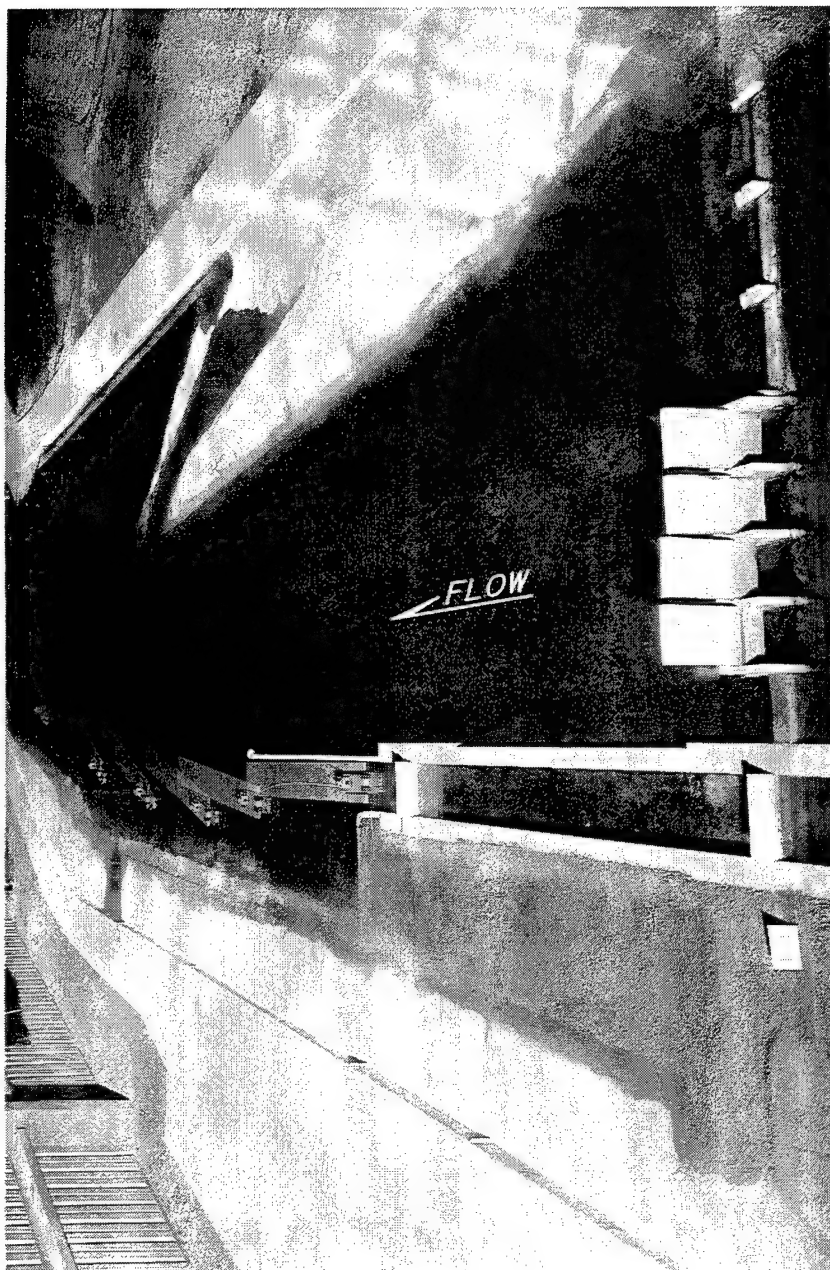
Photo 17. Plan C-1, looking downstream, discharge 134,000 cfs. Path of downbound tow leaving the lower lock approach

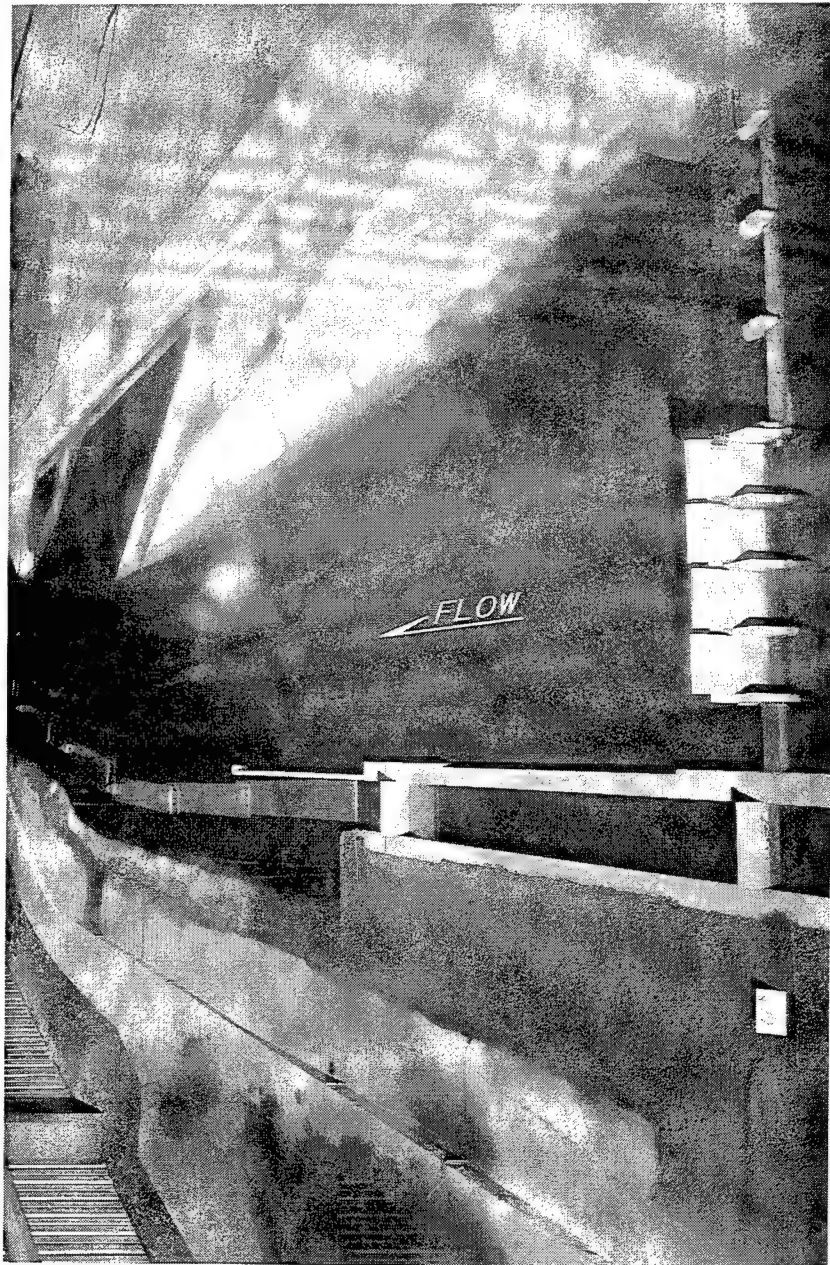
Photo 18. Plan C-1, looking downstream, discharge 60,000 cfs. Path of upbound tow entering the lower lock approach

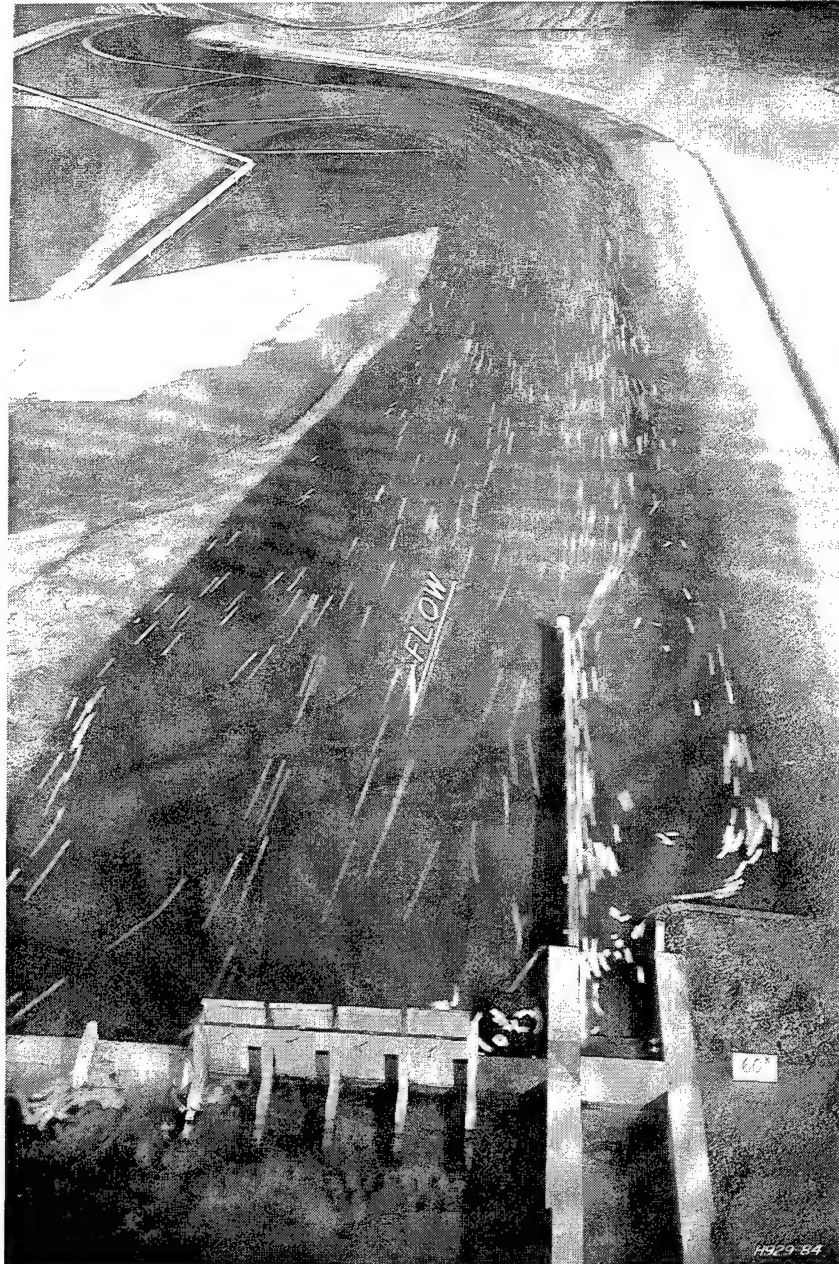
Photo 20. Plan C-2, looking upstream, discharge 60,000 cfs. Confetti showing surface current patterns. Note large eddy landward of guard wall

Current direction and velocity data are shown in Plates 16-20. Surface current patterns are shown in Photo 20. These data indicate that removing the berm provided a more uniform flow distribution in the upper lock approach compared with that of Plan C. However, current magnitudes in the upper lock approach did not significantly change compared with those of Plan C. Current patterns in the upper lock approach were generally parallel to the left bank in the upstream portion of the lock canal, and in the vicinity of the upstream guard wall a fairly strong crosscurrent was observed with all riverflows. The maximum current magnitudes in the upper lock approach ranged from about 2.1 fps with a riverflow of 20,000 cfs to about 10.3 fps with a riverflow of 134,000 cfs. The maximum current magnitude in the vicinity of the upper guard wall ranged from about 1.5 to 7.6 fps with riverflows of 20,000 and 134,000 cfs, respectively. A counterclockwise eddy was observed landward of the upper guard wall with all riverflows. The maximum upstream current magnitude recorded was 1.2 fps with a riverflow of 134,000 cfs.

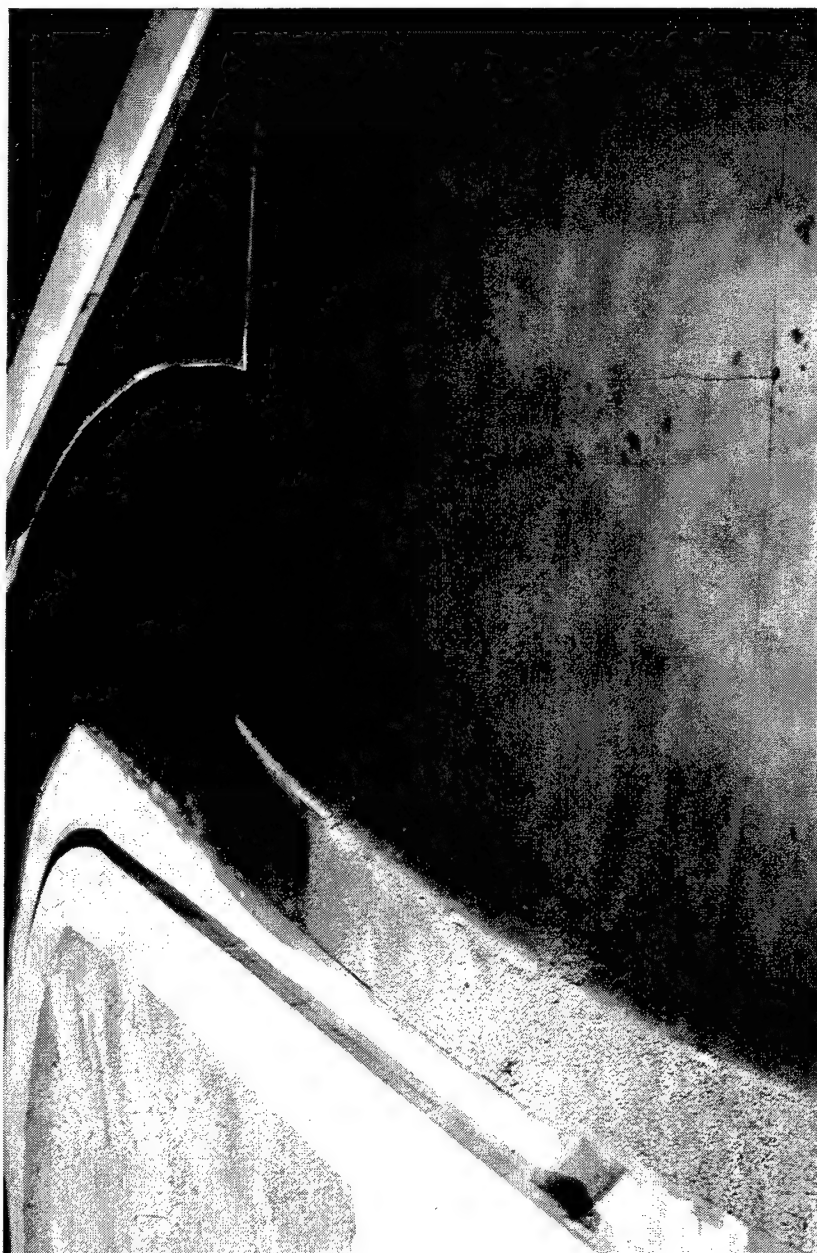
Photo 23. Plan D, looking downstream, showing Bull Revetment and the entrance to Piermont cutoff

Plan D, shown in Figures 11 and 12 and Photos 23-25, consists of the following principal features:

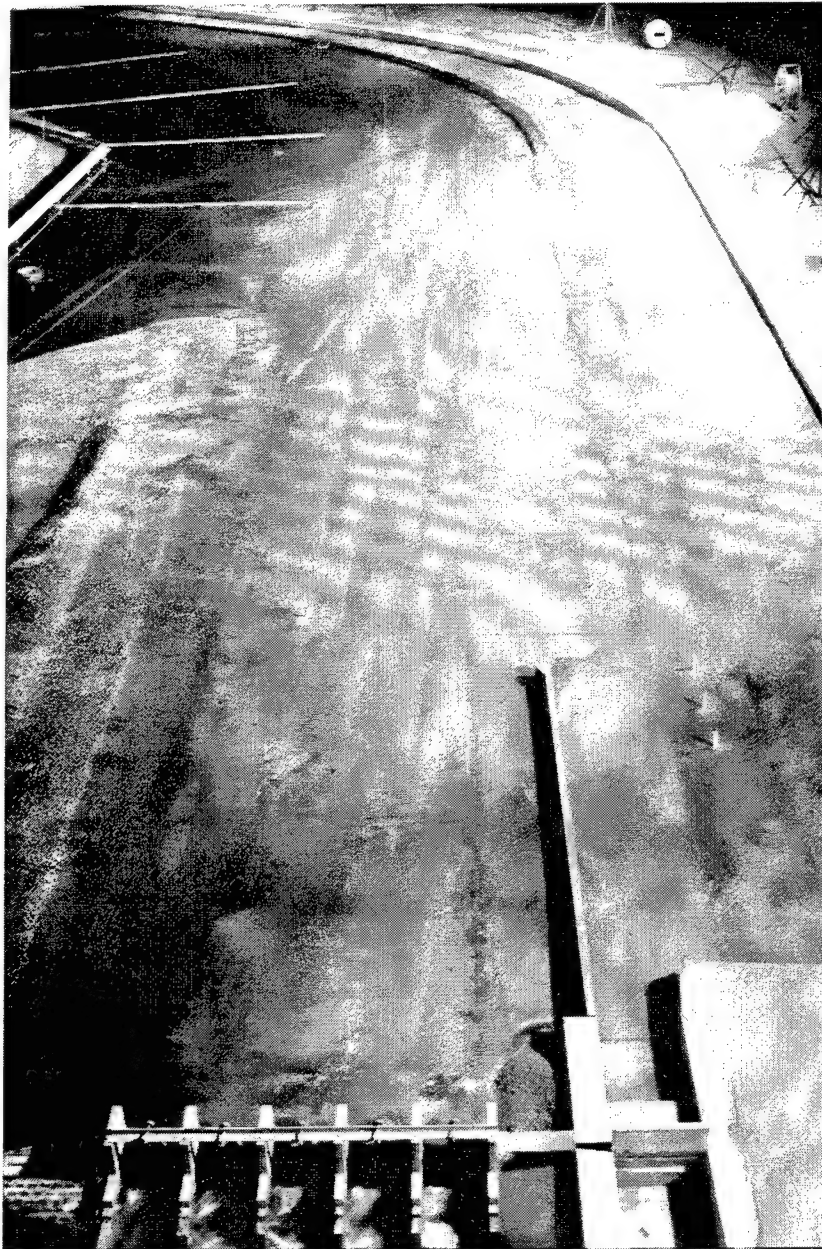
Photo 24. Plan D, looking upstream, showing the upper lock approach

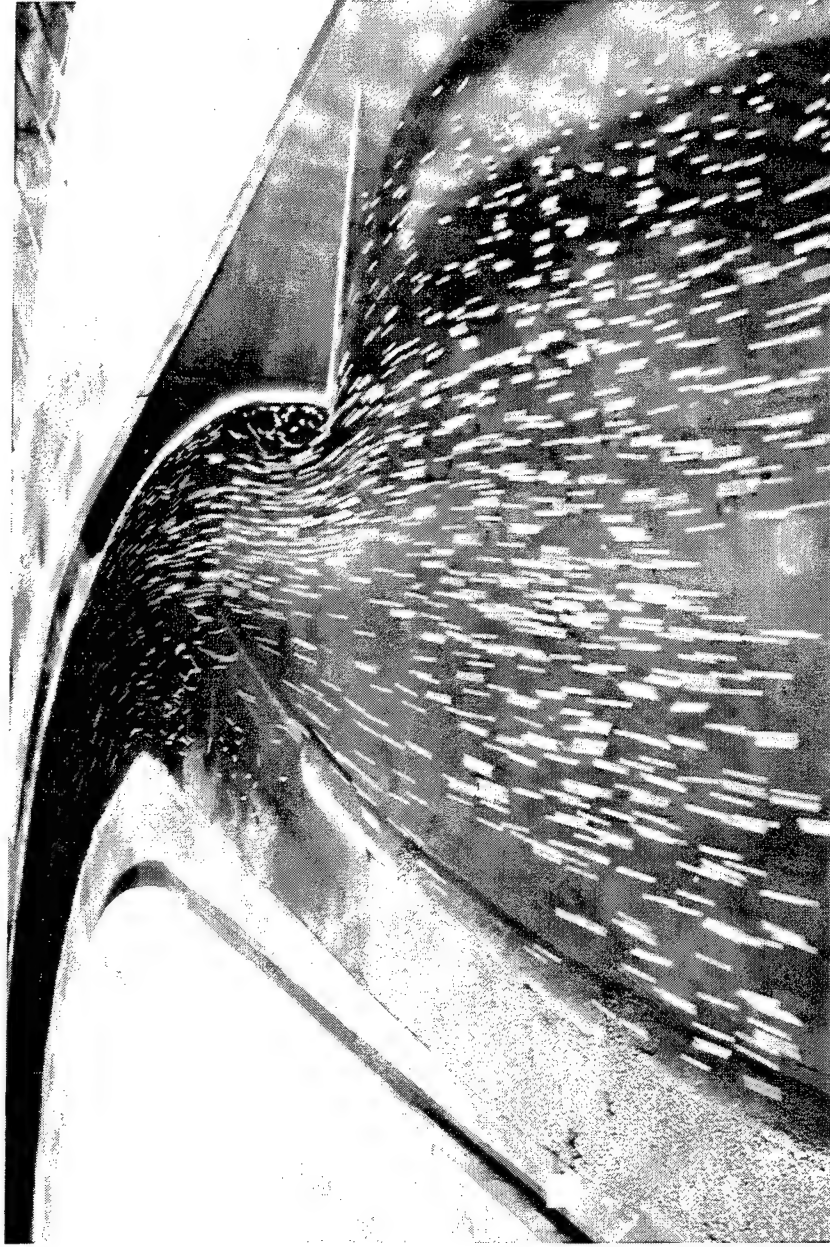
Photo 26. Plan D, looking downstream, discharge 80,000 cfs. Confetti showing surface current patterns

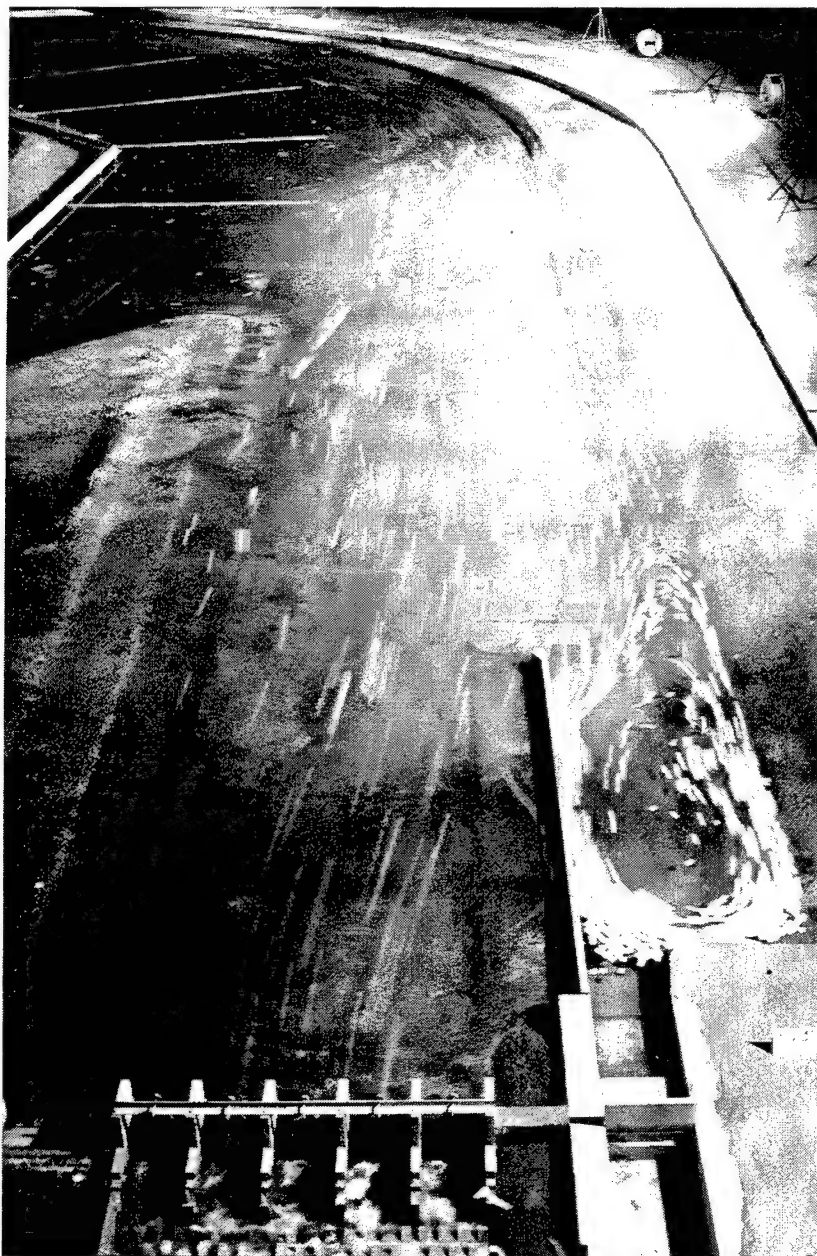
Photo 27. Plan D, looking upstream, discharge 134,000 cfs. Confetti showing surface current patterns. Note large eddy landward of guard wall

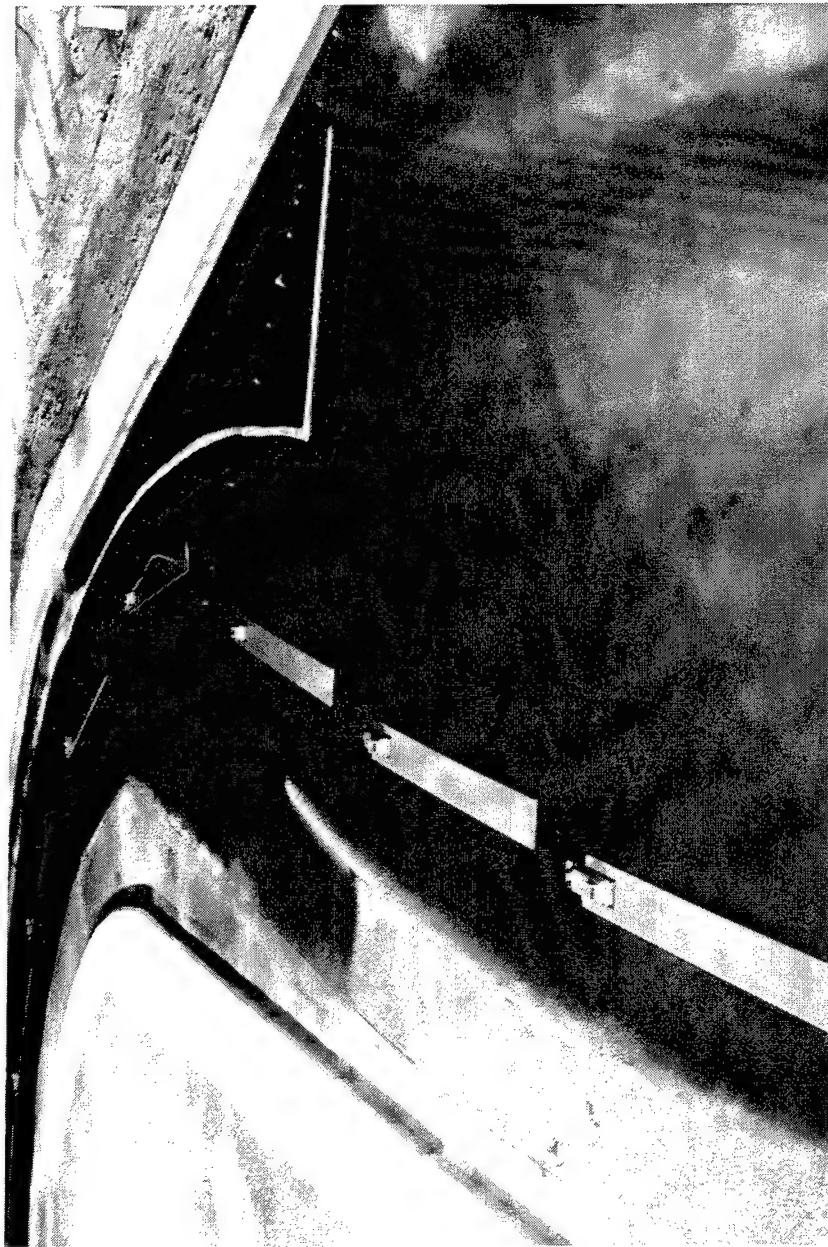
Photo 32. Plan D, looking downstream, discharge 80,000 cfs. Path of upbound tow leaving Piermont cutoff and moving past Bull Revetment. Note tendency for tow to be moved toward Bull Revetment

Navigation conditions were also difficult for upbound tows in this reach of the model. The high-velocity currents moving across the dike and the currents deflected off the right bank revetment tended to move upbound tows from midchannel toward Bull Revetment (Photo 32). Upbound tows leaving Piermont cutoff and moving upstream over the submerged portion of Bull Revetment experienced a very strong tendency to be moved toward or into Bull Revetment. An underpowered tow could experience serious navigation difficulty in this reach of the study.

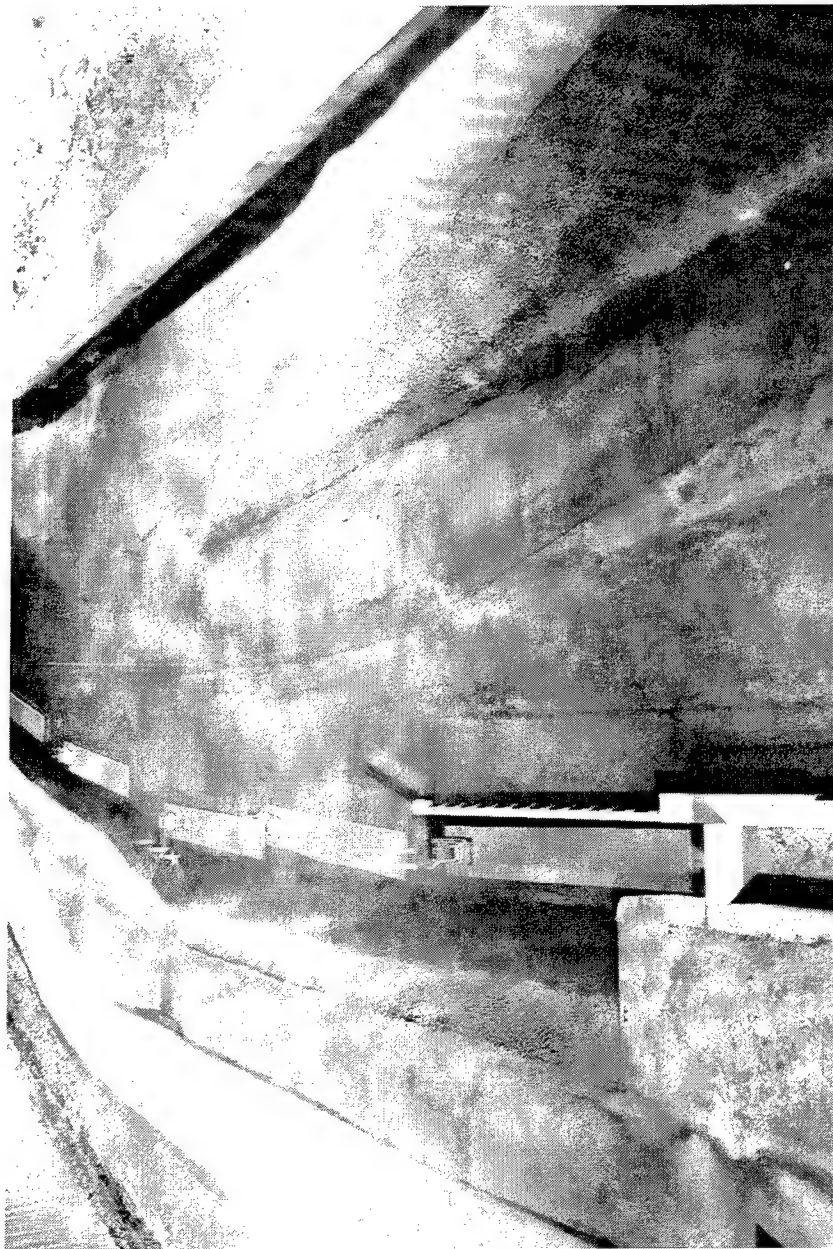
Photo 36. Plan D, looking downstream, discharge 60,000 cfs. Path of upbound tow entering the lower lock approach. Note clearance between tow and mooring dolphins

Navigation conditions were difficult for upbound tows entering the lower lock approach (Photo 36) due to the intensity of the eddy in the lower lock approach. The eddy caused upbound tows to perform additional maneuvering to enter the lower lock approach.

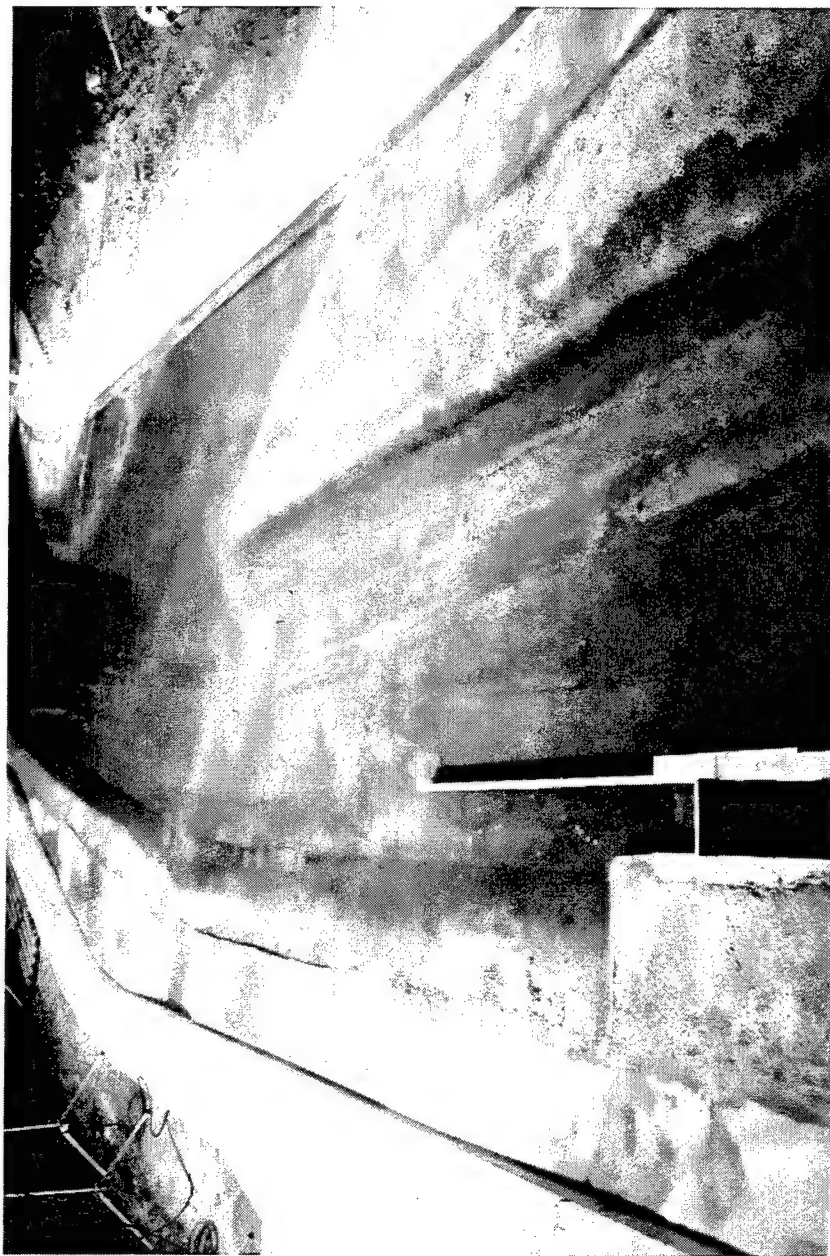
Photo 37. Plan D-2, looking downstream, showing the lower lock approach

Plan D-2, shown in Figure 14 and Photo 37, was the same as Plan D-1 with one exception. The width of the downstream overflow berm with top el 100 on the right bank was reduced to 100 ft wide, thus widening the channel. The transition from the fifth gate bay was revised to accommodate this change. The lower lock approach has a minimum width of 450 ft with bottom el 81.0.

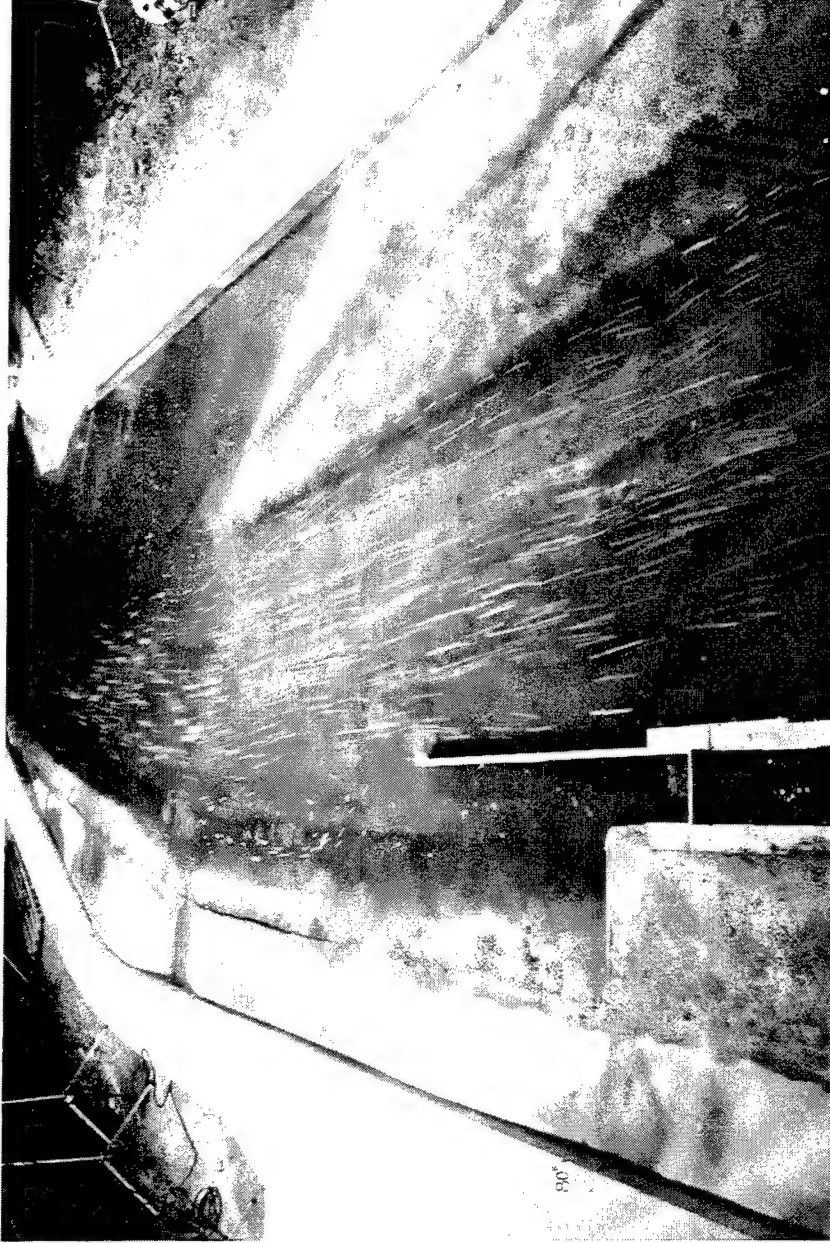
Photo 38. Plan D-2, looking downstream, discharge 80,000 cfs. Confetti showing surface current patterns

Current direction and velocity data are shown in Plates 29-33, and surface current patterns are shown in Photo 38. Current direction and velocity data indicate a 5 to 10 percent reduction in the velocity of the current in the excavated channel. The flow was more evenly distributed across the excavated channel than with Plan D-1. The intensity of the eddy in the lower lock approach was also reduced. The maximum current velocity recorded across the lower lock approach was about 5.0 fps with a riverflow of 100,000 cfs. The maximum upstream current velocity in the eddy in the lower lock approach was about 2.0 fps with a riverflow of 100,000 cfs.
